Saving Salmon One Meter of Shoreline at a Time

A community-based approach to shoreline habitat restoration

Saving Salmon, One Meter of Shoreline at a Time: a community-based approach to shoreline habitat restoration

Cowichan Shoreline Stewardship Project

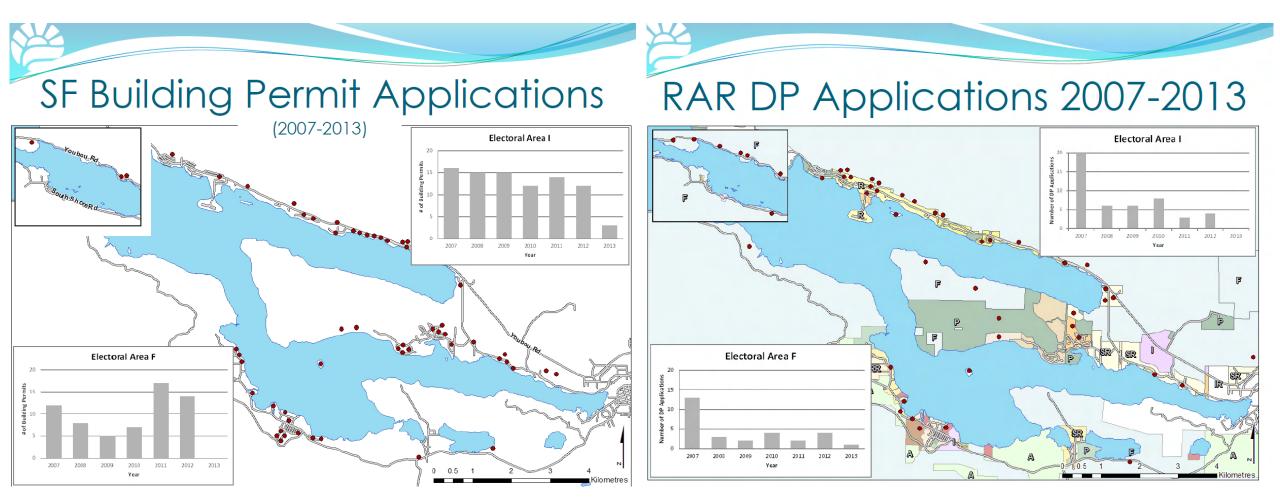
Development around Lake Cowichan

CVRD Area F and Area I Source: "Lake Cowichan Shoreline Workshop", Dec. 2015

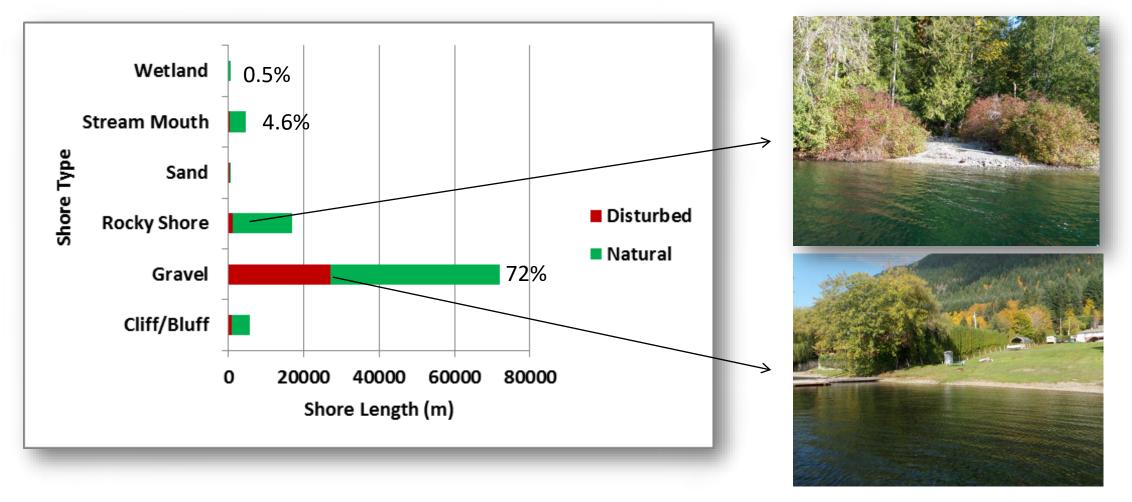
Findings: Shoreline Types and Disturbances

Gravel, cobble shorelines and man-made structures are the most vulnerable to site-specific erosion pressures cause by:

Existing Erosion- Potential Causes

- Seasonal Beach Profile Changes
- Seawall and Groyne Construction
- Climate Change (Wind, Waves, Inflows)
- Cowichan Lake Weir (1961)
- Subsea Landslide at Youbou due to 1946 Earthquake
- Shoreline Vegetation Removal
- Log Boom Installation and Removal
- Vessel Traffic

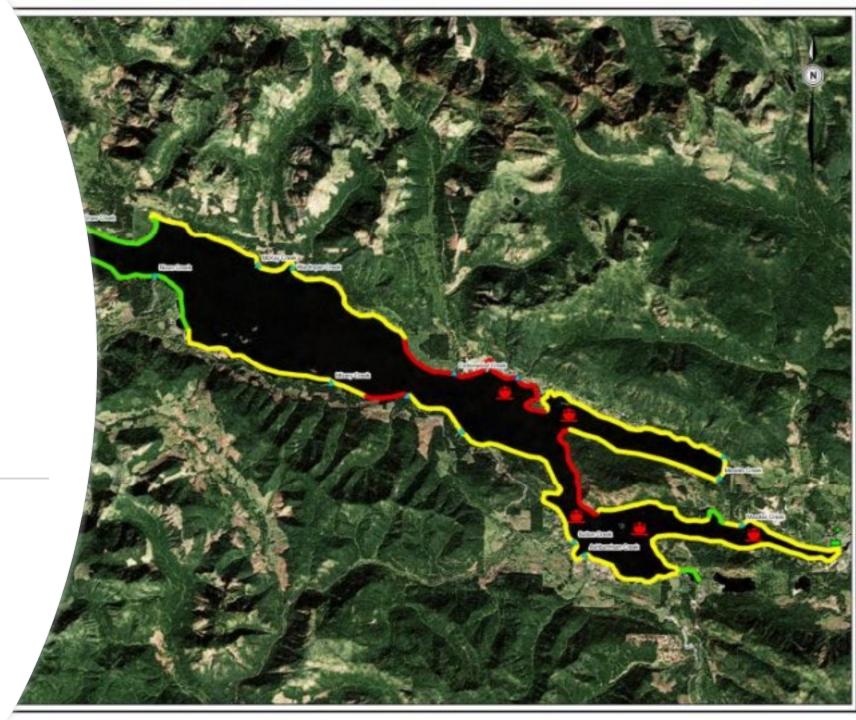
Findings: Action from Waves and Winds tend to magnify erosion risks around the shore

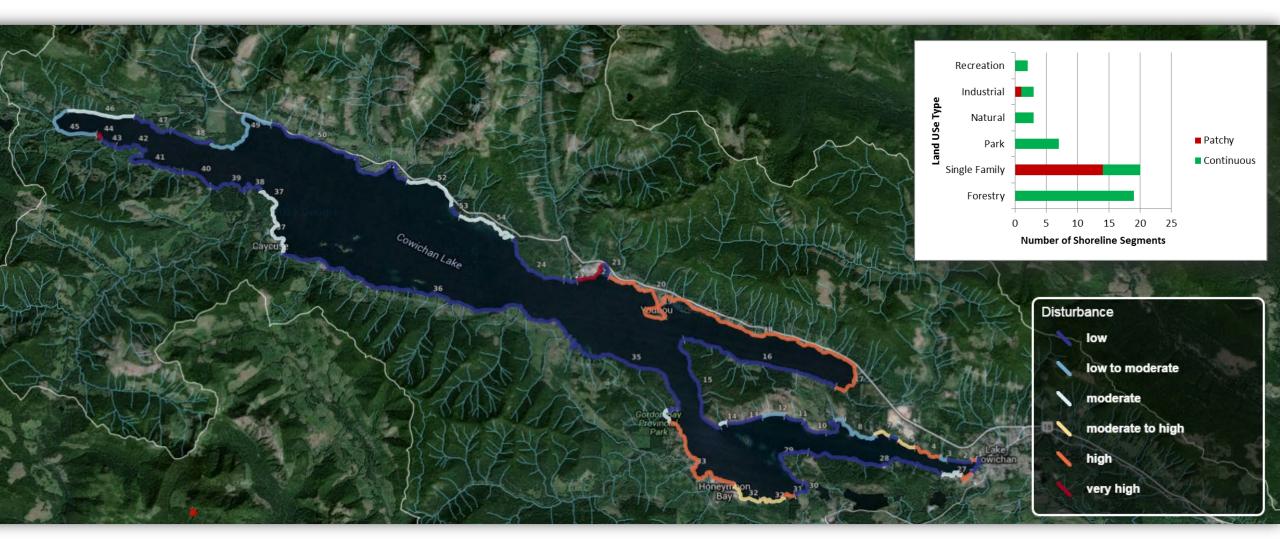
Findings: Riparian disturbances

Findings: Natural vs. Modified shoreline

Main Arm 76% of shoreline remains undisturbed with 20 % of disturbed shore caused by new campgrounds

> South Arm – Town of Lake Cowichan and Honeymoon Bay have highest density of disturbed shores

Impact None Low (<10%) Medium (10-40%) High (>40%)

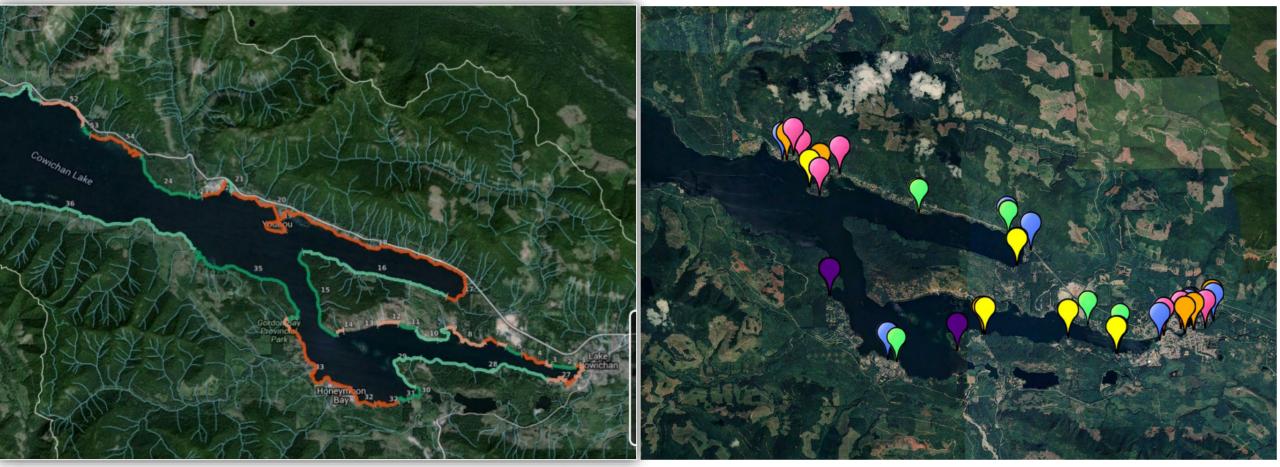
Ecological Restoration

Map of highly impacted shoreline (red)

Map of restored sites between 2014 - 2022

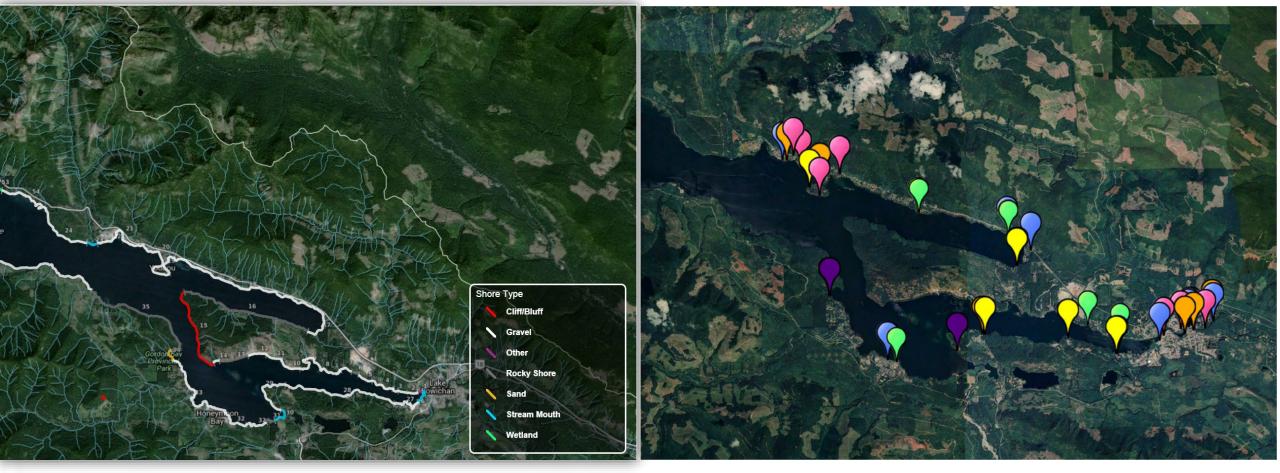
Ecological Restoration

Map of shoreline types

Map of restored sites between 2013 - 2022

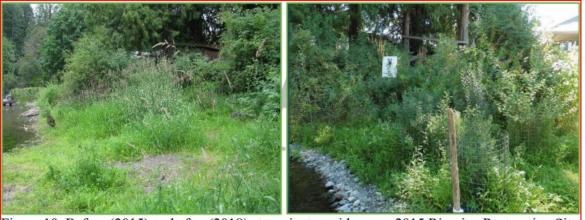
Figure 10. Before (2015) and after (2018) at a private residence, a 2015 Riparian Restoration Site

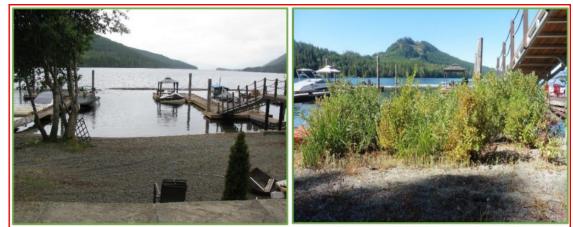
Figure 11. Before (2015) and after (2018) at a private residence, a 2015 Riparian Restoration Site

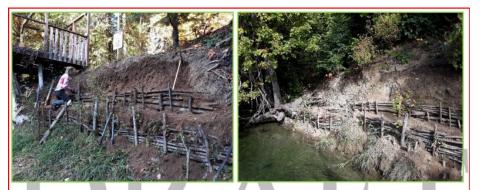
Figure 7. Construction of a live-stake wattle fence at two CSSP 2018 sites along Cowichan River
