Cowichan River Water Quality Update – August 2, 2024

The following information summarizes water quality results for the upper and lower sections of the Cowichan River beginning May 2024. A rigorous monitoring program was put in place as part of a multi-partner plan to avoid another fish mortality event as observed in the summer of 2023. Partners include Cowichan Tribes, BC Fisheries, DFO, CVRD, Town of Lake Cowichan, Municipality of North Cowichan, and the Cowichan Watershed Board. Water quality results are used by the partners to make decisions on required responses to protect fish health and their habitat.

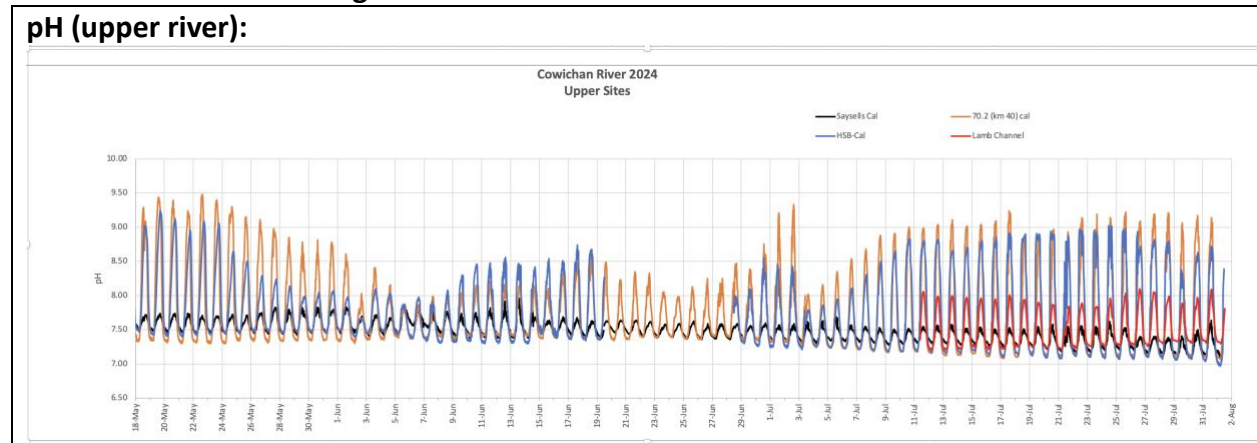
Note: JUB-Joint Utility Board sewage outfall. U/S-upstream. D/S-downstream. HSB-Horseshoe Bend. 70.2-70.2 Mile Trestle. Lamb – Lamb Creek side channel
 Diurnal pH fluctuations result from algal respiration. The Saysell Site is located in the upper river above the Town of Lake Cowichan sewage outfall and represents preferred range in pH diurnal fluctuations. Wide diurnal fluctuations indicate excessive algal growth which is harmful and can be lethal to fish populations.

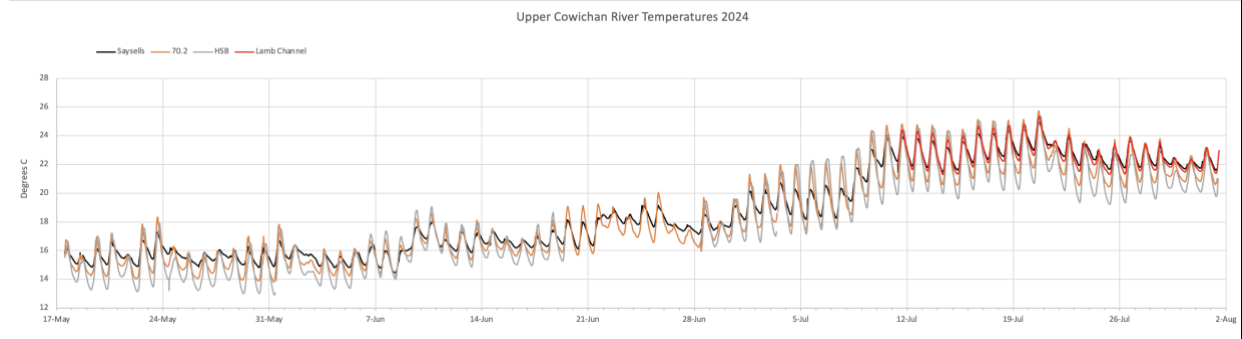
Temperature (upper river):

Note: Water temperatures above 16° C are stressful to salmon and trout. Temperatures above 20° C are extremely stressful and temperatures approaching 24° C can be lethal. Note: Data from Saysell’s site from upper river added for comparison.

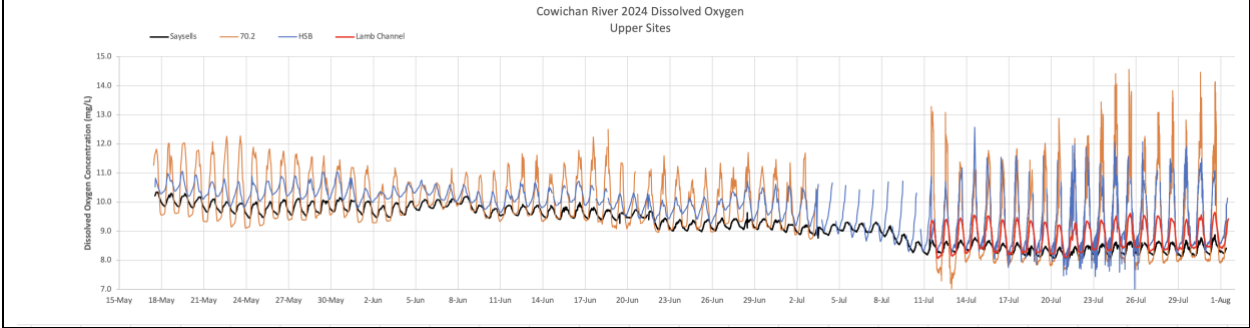
Dissolved Oxygen (upper river):

Note: Diurnal DO fluctuations result from algal respiration. The Saysell Site is located in the upper river above the sewage outfall and represents preferred range in DO diurnal fluctuations. Wide diurnal fluctuations indicate excessive algal growth which can be stressful and in extreme cases lethal to fish populations.
